## Gordon Creek Enhancement Project

**PRIMARY RESTORATION OBJECTIVE:** POST-FIRE RECOVERY

**STRUCTURE TYPE & COUNT:** 16 ± 4 BEAVER DAM ANALOGUES (BDAS)

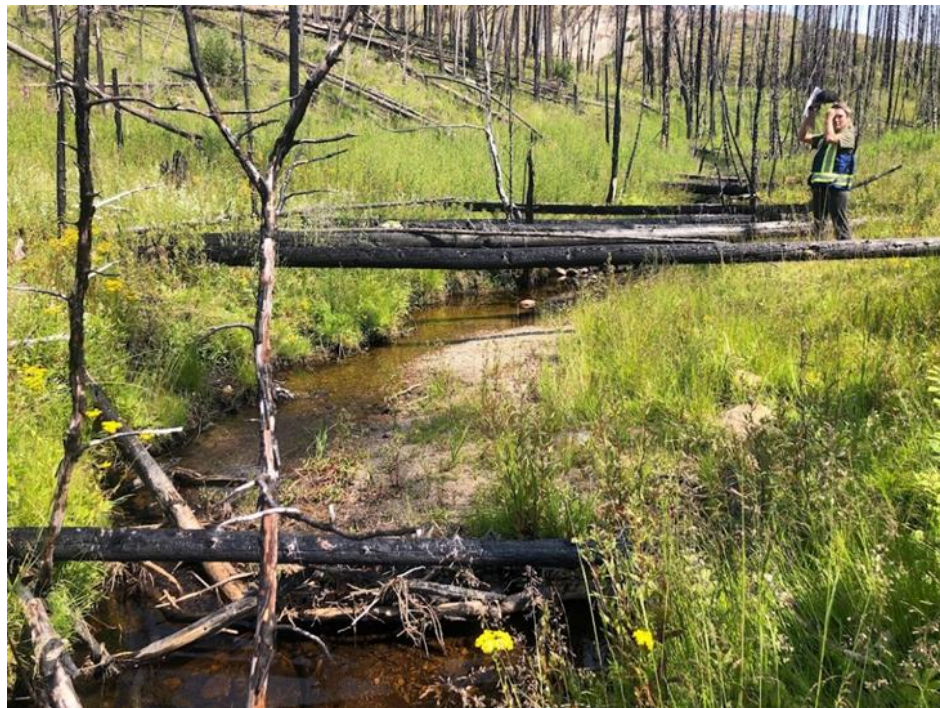
Most vegetation along the stream reach burned in the 2021 Lytton Creek Fire Complex. There is some regeneration of herbaceous species. Sections along the stream reach are in the early stages of channel incision and may become disconnected from their floodplains. The fire has contributed to a flashy stream system, with a greater frequency and magnitude of high flow events, and more severe summer low flow periods.

The project uses BDAs to slow water velocity, promoting sediment aggradation and limiting the potential for channel incision to worsen. BDAs will also increase water residence time, supplementing flows during summertime lows. Planting of deciduous species along the riparian corridor will supplement natural tree regeneration, increase soil and streambank stability, and potentially act as a food source encouraging future beaver establishment.

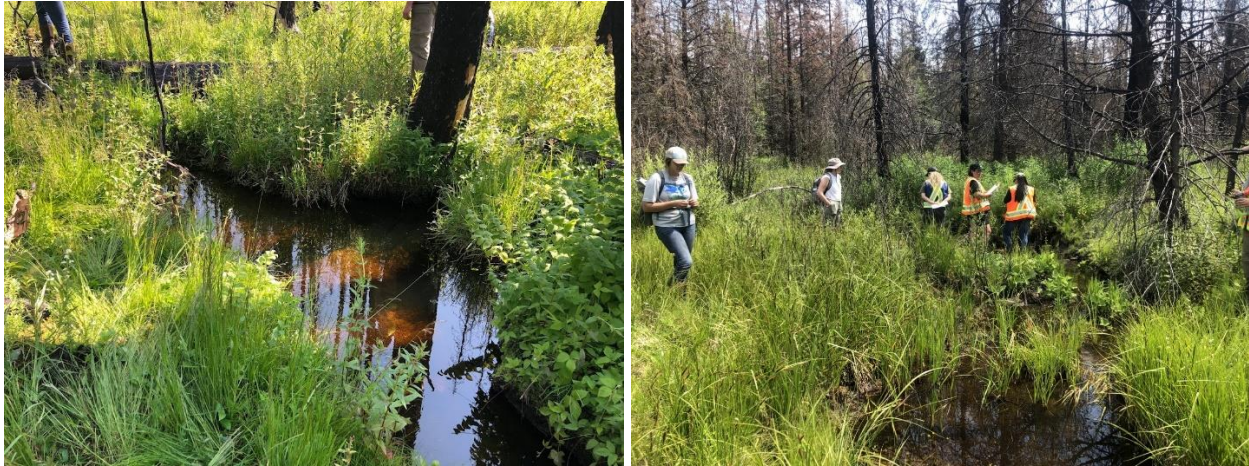
Sections of the stream reach have good herbaceous regeneration post-fire. However, limited instream complexity and summer low flow deficits impact aquatic habitat value.

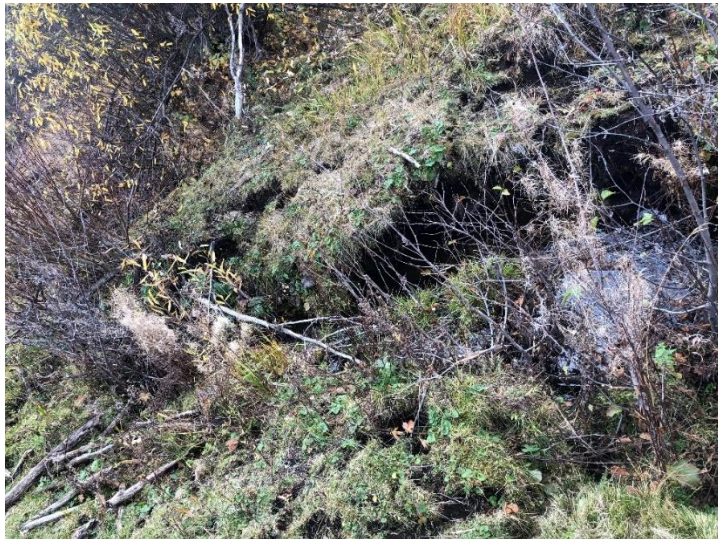
Signs of incision is evident in the downstream reach, with steep vertical stream banks (*left*). Aerial image of the restoration area (*right*).
